# SHOP TALK

VOLUME 6 NO. 1

# THE HAIRLINE PROBLEM

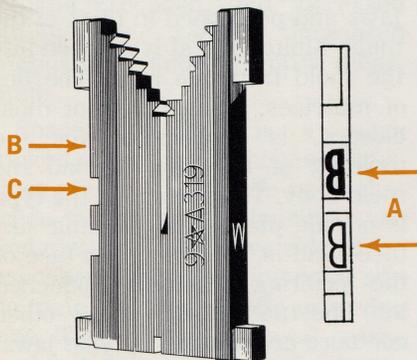
- A. Punched character of matrix (printing plane)
- B. Edge of matrix body (mold height plane)
- C. Side wall of punched character (between printing plane and mold height plane)

Examine a matrix and note how slight the difference is between the side wall and printing plane. The side wall is not always a straight line as in the above figure, but in the case of the letter "O" has a depression in the center. Other characters show the depression in various locations along the side wall area.

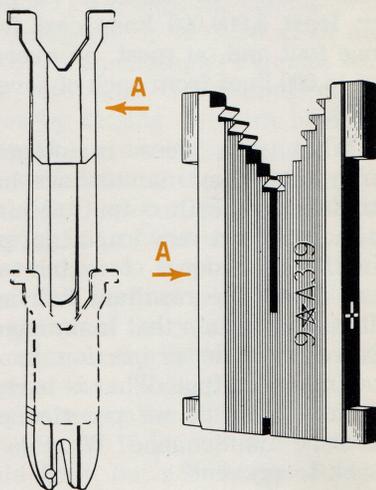
- A. Edge of spaceband and quad matrix (mold height plane)

In the spacebands and quads we have but one plane. But, and a very big but, we find that spacebands and quads appear in the contour of the cast slugs showing more than their edges. The sides of spacebands and quads are also

exposed to the molten metal to the extent of the difference between the side wall plane and the mold height plane of the matrices they adjoin.

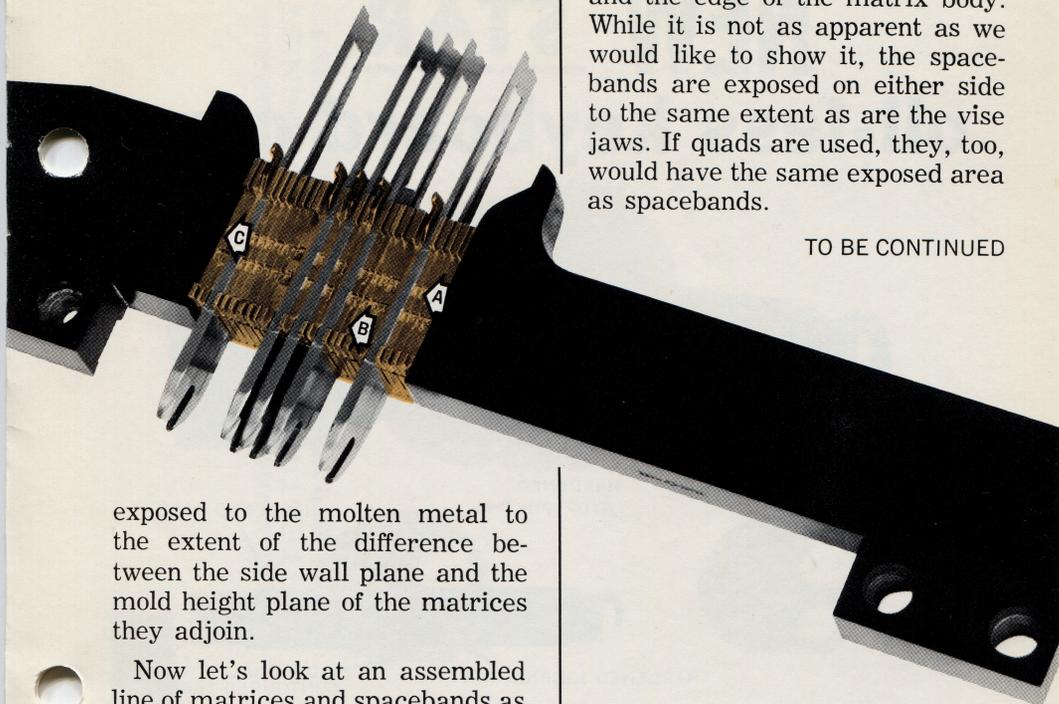
and the edge of the matrix body. While it is not as apparent as we would like to show it, the spacebands are exposed on either side to the same extent as are the vise jaws. If quads are used, they, too, would have the same exposed area as spacebands.

Now let's look at an assembled line of matrices and spacebands as it would be positioned before the mold during the actual casting of a slug.

- A. Punched character of matrix (printing plane)
- B. Edge of matrix body (mold height plane)
- C. Side wall of punched character

Note how the various planes mentioned before appear during the cast.

Note particularly point C. The vise jaws which squeeze the line of matrices and complete the closure of the front of the mold are flush with the mold body B. It will be readily seen that the faces of the vise jaws that contact the matrices are exposed to the molten metal to the extent of the difference between the side wall plane

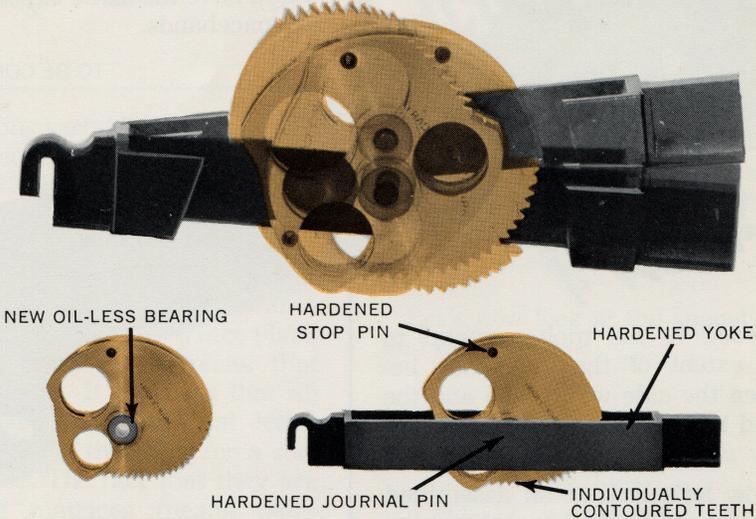
# NEW STAR oil-less keyboard cams

The new Star oil-less keyboard cams never require lubrication. They are equipped with engineered plastic bearings, which revolve on hardened journal pins. These special bushings practically eliminate friction and reduce maintenance to near zero.

Other advantages of the improved Star cam include individually contoured teeth which grip the rubber roll to give fast, positive lift to the key rod. Both the cam stop pin and yoke are hardened, providing long trouble-free life.
